FIGURE 31.—The Lackawaxen Aqueduct, looking northeast toward the Delaware. As at Pittsburgh, Roebling arranged the floor beams and side struts of the Delaware & Hudson Aqueduct trunks into simple trusses that both supported the overhanging towpaths and resisted the side pressure of the water on the trunk walls. (Photograph courtesy of Delaware & Hudson Railway Company.)

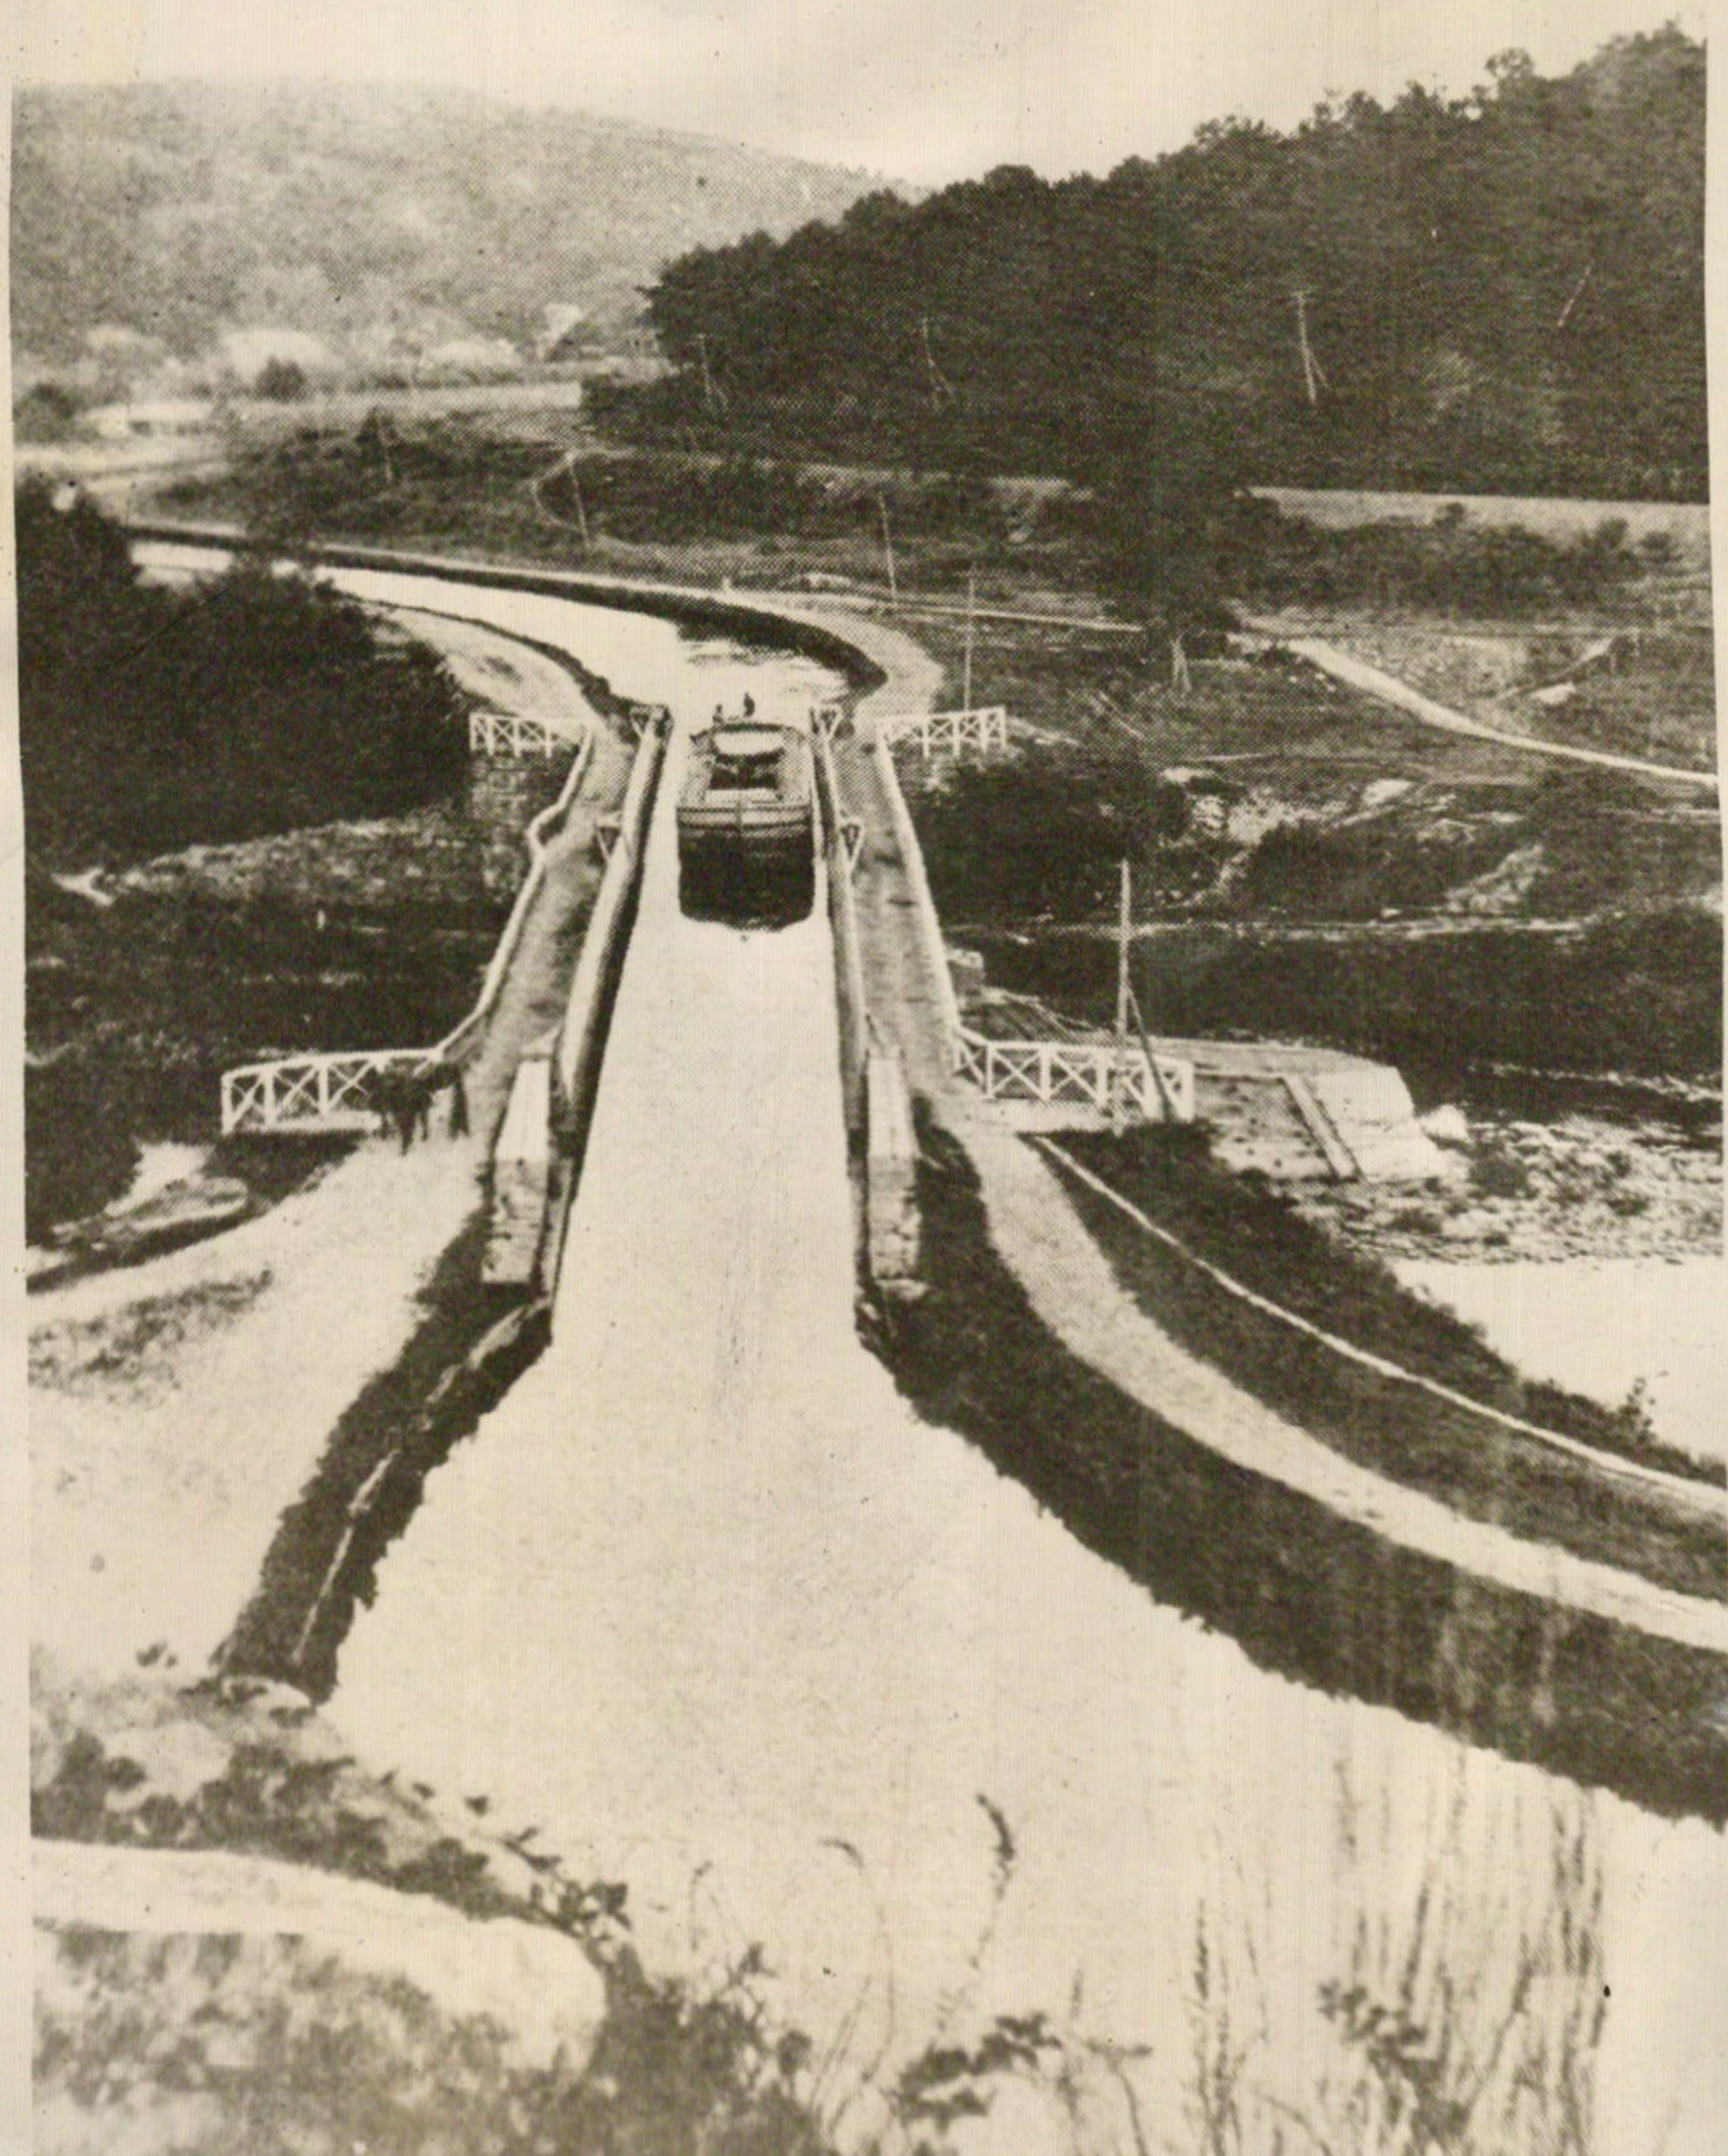
FIGURE 34.—Remains of the Lackawaxen Aqueduct. Only the west abutment survives, the east abutment and the midriver pier having been entirely demolished for the conveniently located supply of cut stone. (Historic American Engineering Record and the Smithsonian Institution.
